The Road Inventory of Irrigon National Fish Hatchery Irrigon, OR

Prepared By:
Federal Highway Administration
Central Federal Lands Highway Division
March 2013

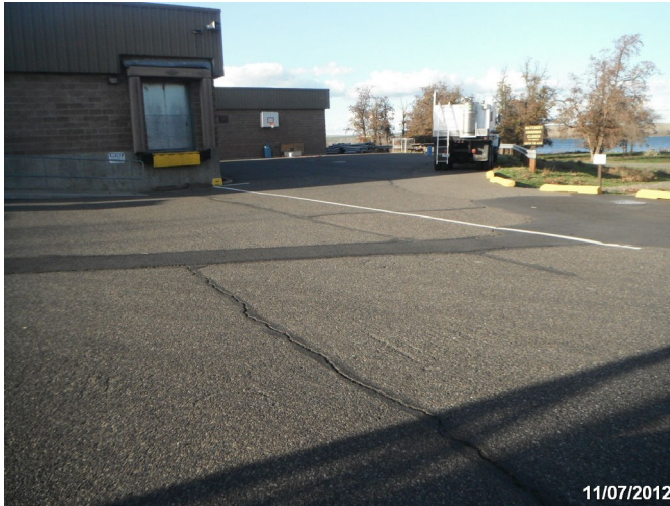
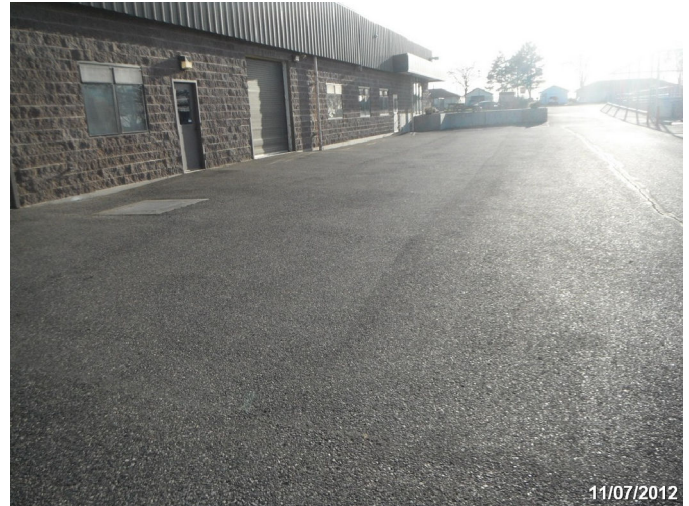
Route Number:800

Asset Number	Area (Sq Ft)	Condition	Surface Type	Cost to Improve	Inspection Date	Current Replacement Value
10057561	23440	Fair	Asphalt	\$22,500	11-07-2012	\$238,600

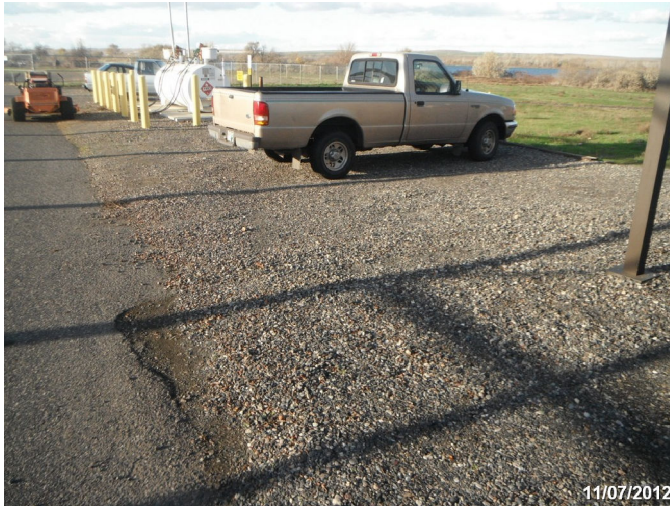
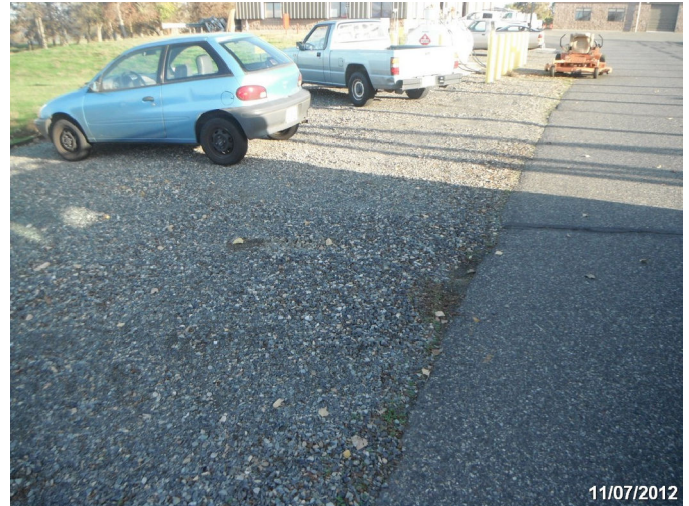
Route Number:801

Asset Number	Area (Sq Ft)	Condition	Surface Type	Cost to Improve	Inspection Date	Current Replacement Value
10057563	2400	Good	Gravel	\$400	11-07-2012	\$13,300

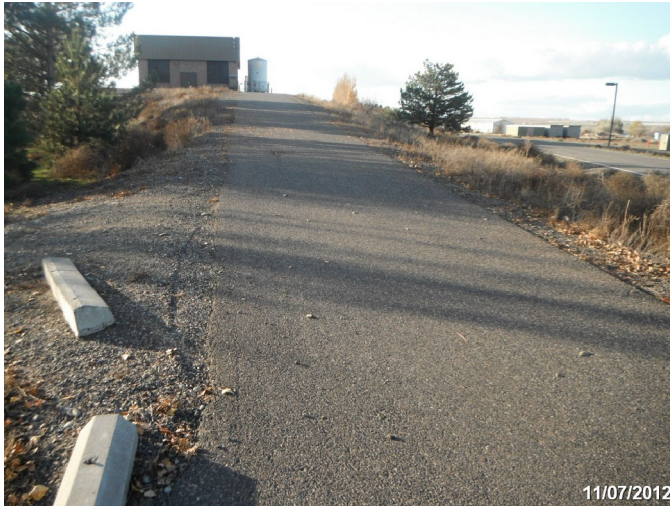
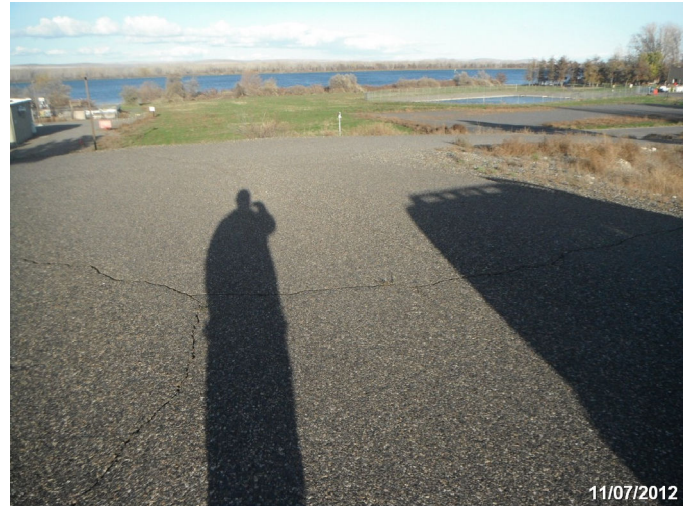
Route Number:802
Hatchery Gravel Aeration Building Parking
 From Riverview Lane (Route 010)

Asset Number	Area (Sq Ft)	Condition	Surface Type	Cost to Improve	Inspection Date	Current Replacement Value
10057561	4675	Fair	Asphalt	\$4,500	11-07-2012	\$47,600

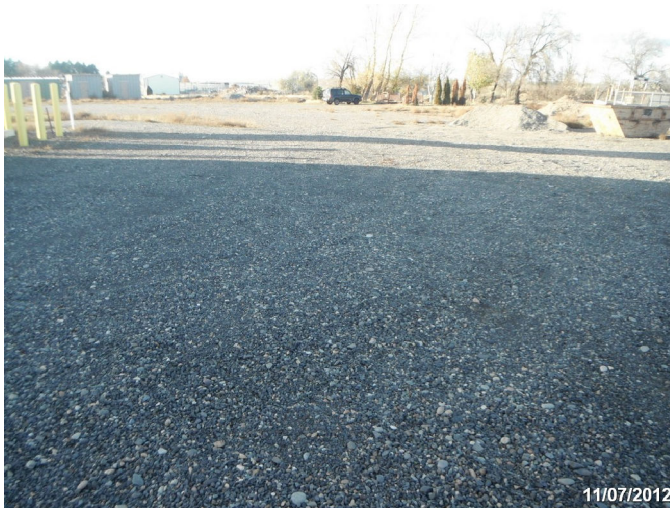
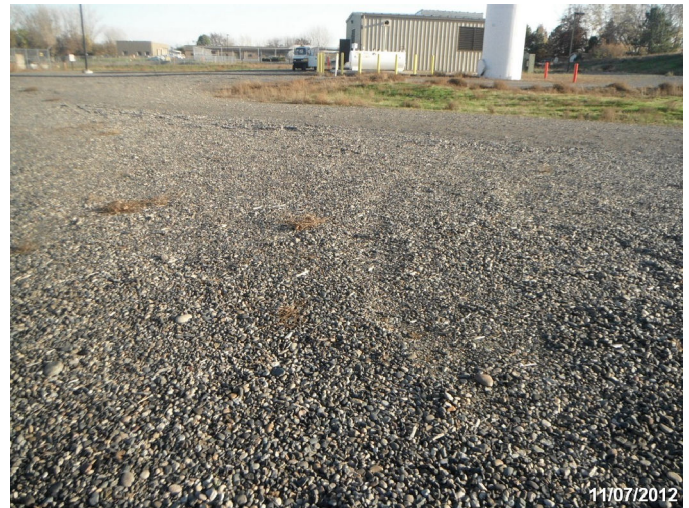
Route Number:803

Asset Number	Area (Sq Ft)	Condition	Surface Type	Cost to Improve	Inspection Date	Current Replacement Value
10057563	34418	Fair	Gravel	\$10,200	11-07-2012	\$191,200

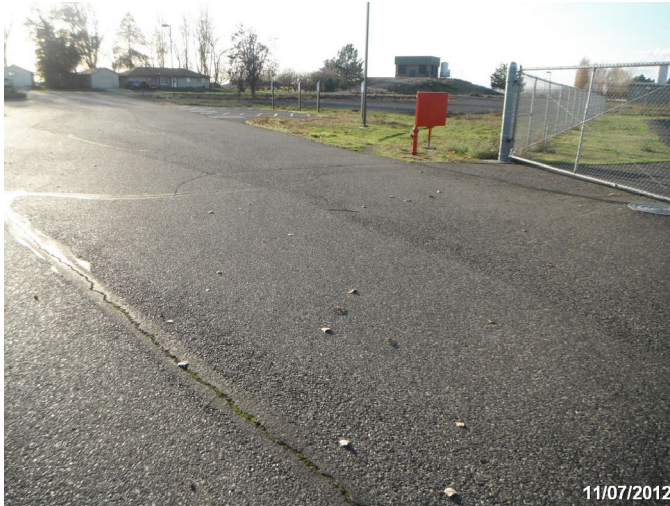
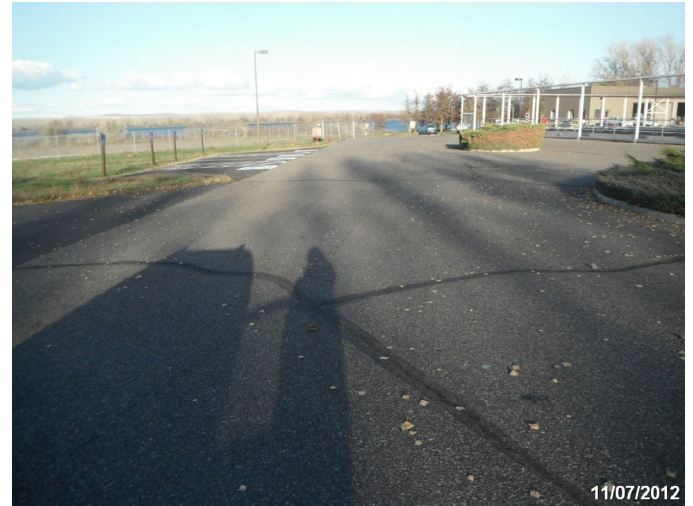
Route Number:901

Asset Number	Area (Sq Ft)	Condition	Surface Type	Cost to Improve	Inspection Date	Current Replacement Value
10057561	11722	Good	Asphalt	\$2,400	11-07-2012	\$119,300

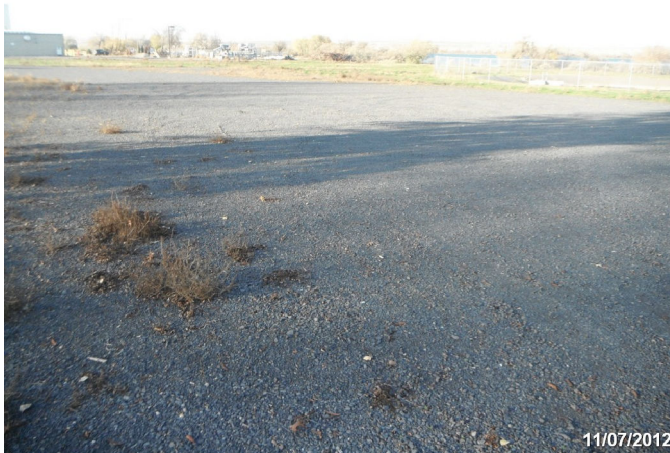
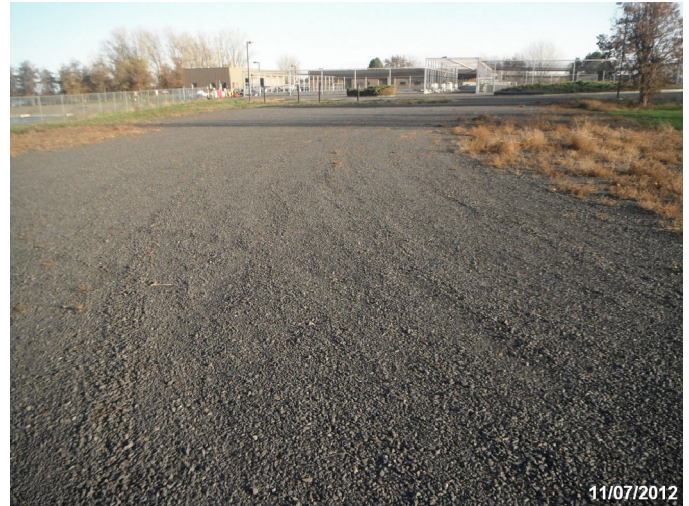
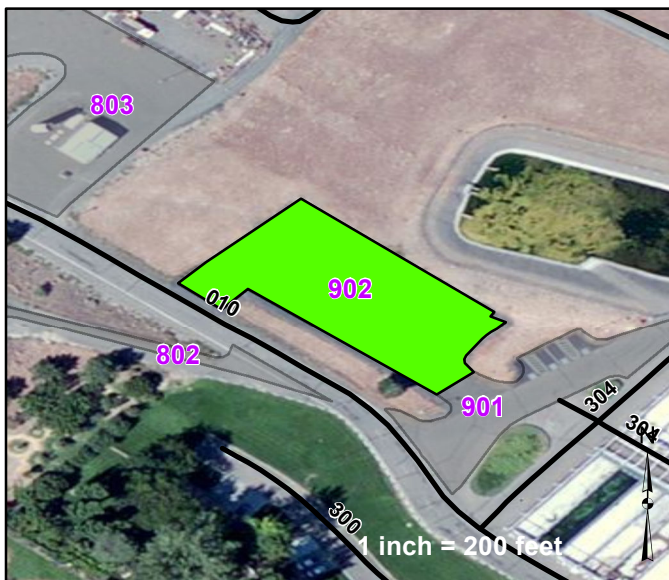
Route Number:902

Asset Number	Area (Sq Ft)	Condition	Surface Type	Cost to Improve	Inspection Date	Current Replacement Value
10057563	19534	Good	Gravel	\$3,300	11-07-2012	\$108,500

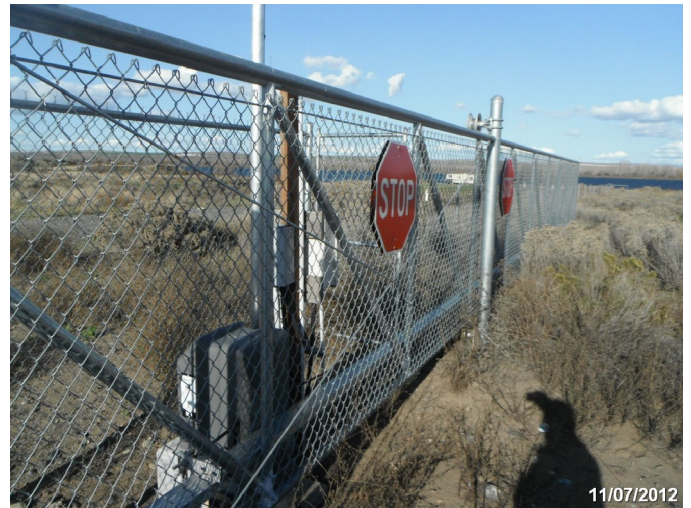
Photo: IRRG_C4_0641 Route: 010-002-1.83
Metal Chain Link Gate Electric
Asset# 10003044
